COMMANDER'S EMERGENCY RESPONSE PROGRAM: MUHALLA 312 ELECTRICAL DISTRIBUTION PROJECT LARGELY SUCCESSFUL

SIGIR 09-025 July 26, 2009

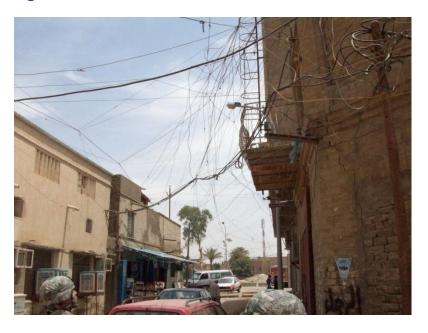
On May 20, 2009, SIGIR visited Muhalla 312 and observed that the GOI was sustaining the electrical distribution grid project. While visiting the project, SIGIR observed several of the installed kiosks and pillars and confirmed that power lines from the distribution project were not visible. The cables from the kiosks were buried to prevent tapping into the power source. Further, SIGIR observed that the contractor had secured each of the kiosks and pillars with padlocks and metal bands. SIGIR observed that none of the kiosks or pillars appeared to have been tampered with (see Figures 2 and 3). According to an MND-B official, the project included the installation of 469 high-pressure mercury street lamps connected to the new distribution lines; cables from the kiosks and pillars are underground at least one meter to deter residents and shop owners from illegally tapping into the distribution lines. As shown in figures 4 and 5, the neighborhood appears to have a large amount of resident-installed electrical lines strung from building to building, which increases the risk of electrocution and disruption of power.

Figure 5—Resident-Installed Electrical Lines in Muhalla 312
